REMEDIAL MEASURES FOR  
HOUSES DAMAGED BY  
EXPANSIVE CLAY

April 5, 1978

The University of Texas at Arlington  
Under Contract No. H-2240-R

U.S. Department of Housing and Urban Development  
Office of Policy Development and Research

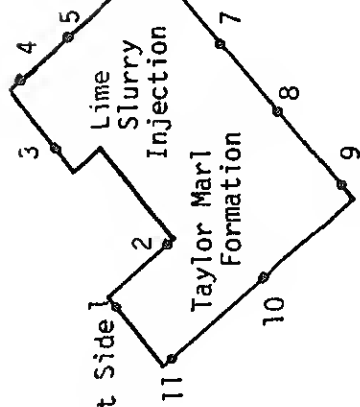
Fig. 14 Differential Elevation on Slab Perimeter

The vertical movement of the foundation slab appears to be approaching a stable condition as indicated in Figure 13, for the same reasons as given in paragraph 3.3.1. Also indicated is the lag time behind the mid point of a climatic cycle. Figure 14 indicates the maximum differential movement with time along sides of the house, and is also given in tabular form in Table 4.

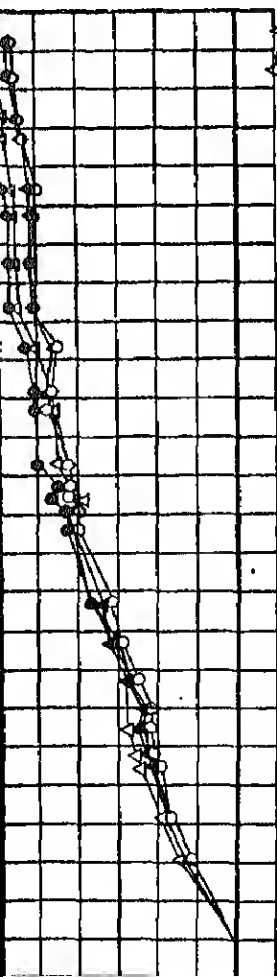
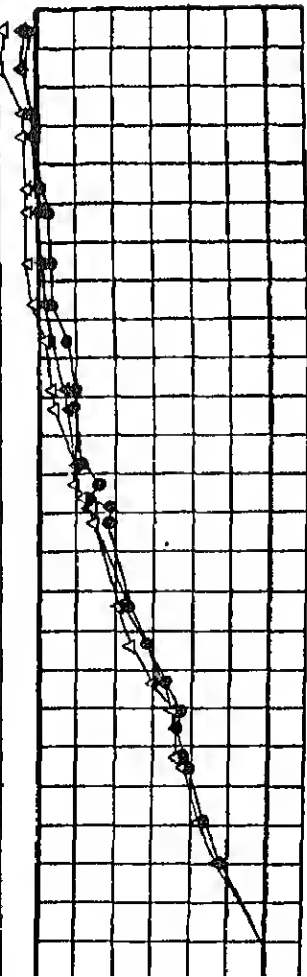
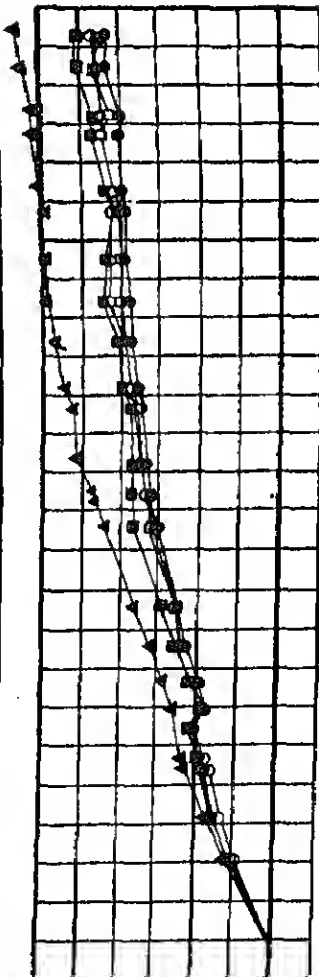
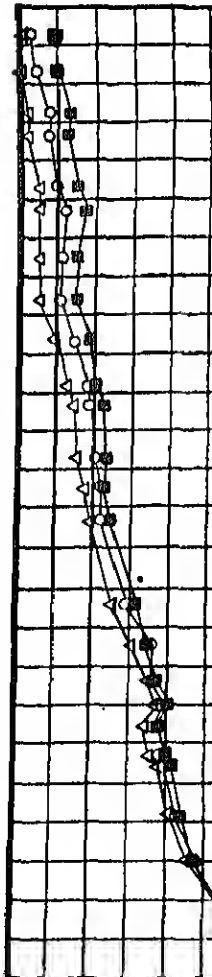
Fig. 23 Differential Elevation on Slab Perimeter  
9909 Bluffcreek, Dallas, Texas

Figure 22 shows the vertical movements along each side of the house as of time, and Figure 23 indicates the maximum change in elevation along each side of the house. Data presented is for a performance two years and represents the climatic effects over approximately two annual cycles. Both the northeast and southeast corners of the floor are at approximately the same elevation, with the midpoint along the east side of the perimeter beam being slightly higher. The southwest corner is lower; however, change in elevation along the short west side is significant. The south side of this house has the greatest differential movement in corners. Analyzing the configuration of the south side and the data from level pins 4, 5, 6, 7, and 8, would indicate that climate, soil, and effects of home maintenance are important considerations. The southwest corner and even more so at the change in floor plan shown at level pins 6 and 7 where essentially there are two additional vertical planes subjected to the previously mentioned considerations. The corner at level pin 6 may be postulated as being subjected to the effects of climate, as accumulated data would indicate. In effect, this may be considered an extension or continuation of the length of the test house where climatic effects are more pronounced in

the vertical movements of all sides of the house are significant. Figure 22, the differential movements as given in Figure 23, show that the east and west sides have the greatest physical effect on the house floor slab. The change in elevation between leveling points are relatively small, indicating the effectiveness of this stabilization technique. Finally, Figures 22 and 23 indicate climatic effects are being dampened out and the change in elevation between leveling points may be attributed, to some extent, to changes in the subsoil physical properties at different locations around the perimeter of the house.

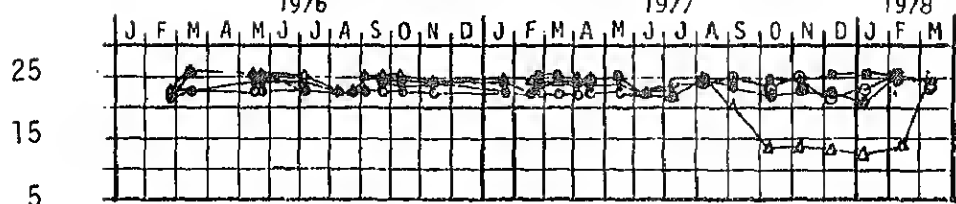
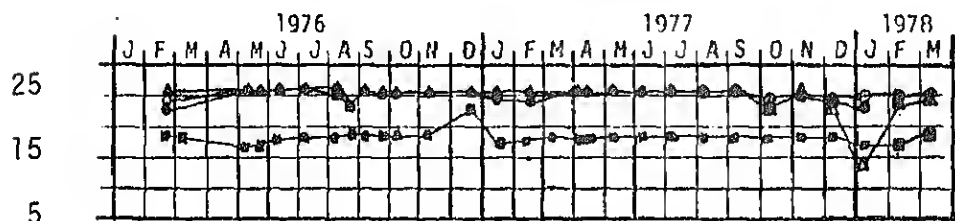
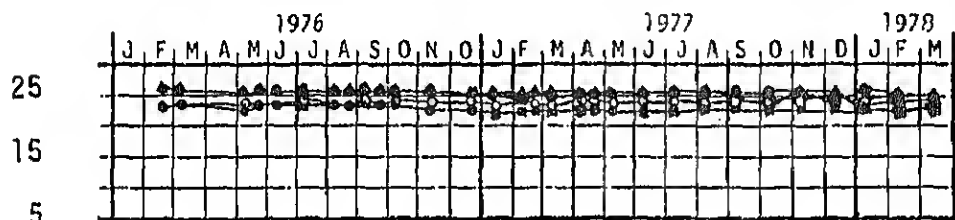
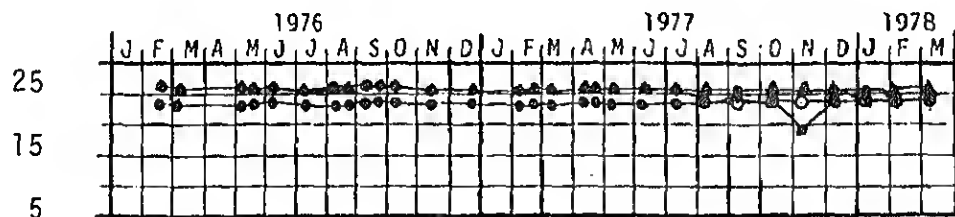
Fig. 25 Soil Moisture Content - Capillary Barrier  
1642 Cedar Keys Drive, Lewisville, Texas

The acquisition for variation in soil moisture content with time, as shown in Figure 25, commenced upon completion of actions associated with installation of the capillary barrier as a subsoil stabilization technique. It is apparent that the increase in moisture content in the subsoil at all depths of interest was relatively successful. The narrow band width of soil moisture contents for each depth and with time indicates the stability of the installation and effectiveness of the capillary barrier in inhibiting moisture loss from the subsoil.

An anomaly is apparent for the curves given in Figure 25, at a depth of 10 feet below the perimeter beam. The moisture cells installed in the boring on the west side of the house indicate a moisture content significantly less than on the other three sides of the test house. This anomaly may be due to variation of soil properties at this depth and on the east side of the house. The investigation boring log indicated a natural moisture content approximately 10 percent above the Plastic Limit at this depth of interest and it is probable that less than desired intimacy of contact is existing between the soil and the moisture cell.

The average natural soil moisture content from the soils investigation was 10 percent to a depth of five feet. The average Plastic Limit to the subsoil was 20 percent. Figure 25 shows the moisture contents at all depths of the subsoil to be at least 2-3 percent above the Plastic Limit and to have relatively constant values with time. The exception to this state-ment has previously been discussed. In addition, climatic effects are not observed affecting subsoil moisture to any significant degree, within the soil mass stabilized by the capillary barrier.

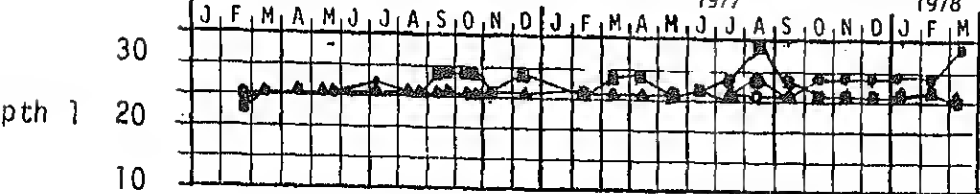
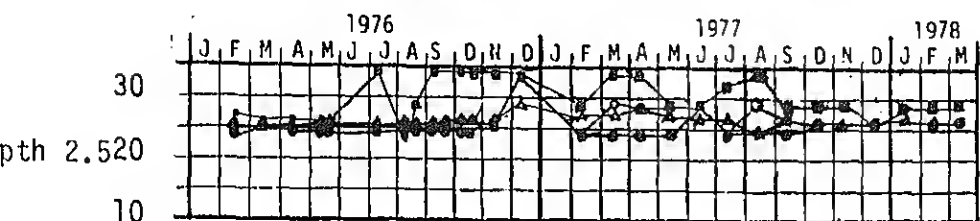
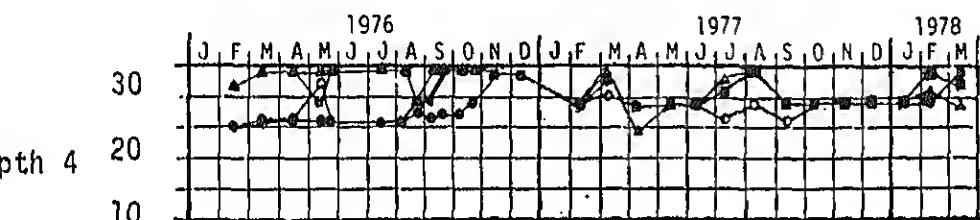
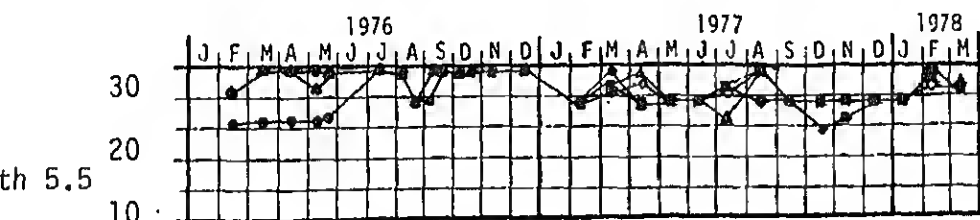
Fig. 27 Soil Moisture Content - Capillary Barrier  
9909 Bluffcreek, Dallas, Texas

Data acquisition for monitoring subsoil moisture characteristics with time is given in Figure 27. Acquisition commenced upon completion of actions associated with the use of a capillary barrier as a subsoil stabilization technique. It can be seen that the moisture content to depths of interest were increased and maintained well above the Plastic Limit of the soil. Figure 27 also illustrates the dense characteristics of the Taylor formation. The fluctuation of the soil moisture continued over a period of approximately 8-9 months before stabilizing into a narrow band width. It is noted that the fluctuation of magnitude of soil moisture was in a range above the Plastic Limit which was desired.

The average natural moisture content of the soil within the depths of interest was 13.8 percent, with the largest variation of moisture content below the Plastic Limit being 7.7 percent. The average Plastic Limit within the depths of interest was 19.4 percent with the variation being approximately 2 percent. It is emphasized that any free water associated with climate or home maintenance is not inhibited from crossing the capillary barrier and being taken into the foundation soil, if the soil moisture demand of the clay minerals is deficient in satisfying the double layer water requirement. The objective for increasing the subsoil moisture content was to be minimum of 2-3 percent above the Plastic Limit of the soil. Any increase in moisture beyond that minimum was a more positive action.

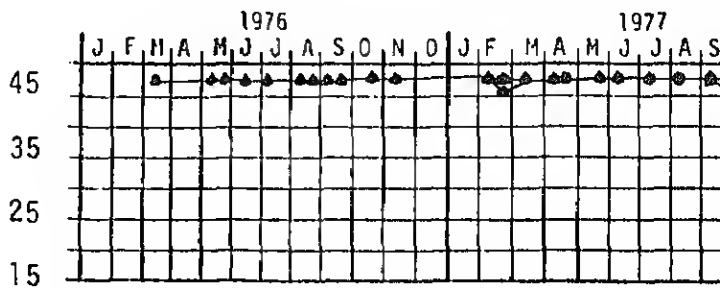
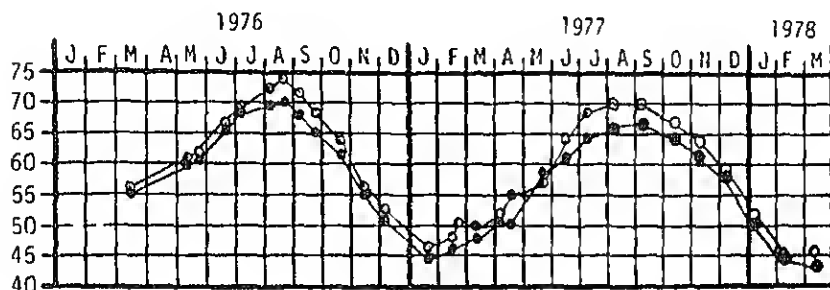
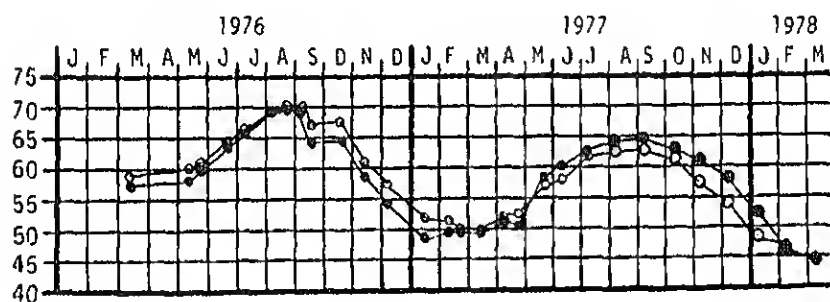
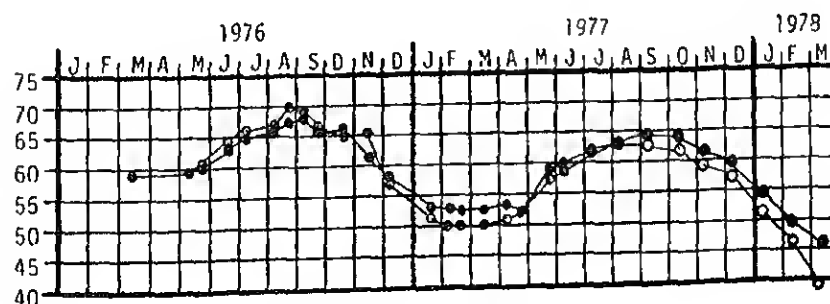
\* Refers to Depths Below Perimeter Grade Beam  
 Fig. 36 Soil Moisture Content - Rubber Barrier  
 1314 Athens Street, Mesquite, Texas

is submitted that an undetermined volume of the added water was lost to significant depths in the subsoil and also to soil outside the rubber barrier by the ready avenues of escape provided by fractures and cracks in the formation subsoil. As the soil expanded and gradually restricted these flow paths, the increase in soil moisture was obtained in the soil mass surrounded by the rubber barrier.

For the test house at 1314 Athens Street, Mesquite, Texas, the variation in soil moisture with time as given in Figure 36, page 80, is relatively uniform at all depths of interest. It is reiterated that a much larger volume of water was introduced into the subsoil surrounded by the relatively impermeable rubber barrier. The soils of this formation are dense and fractured and it was believed a significant quantity of water was able to migrate to great depths and outside of the barrier perimeter. Consequently, a much greater mass of soil, also containing a significant percentage of Montmorillonite clay, was able to experience its swell potential.

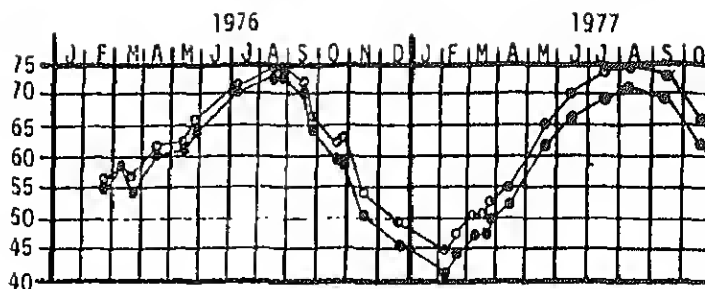
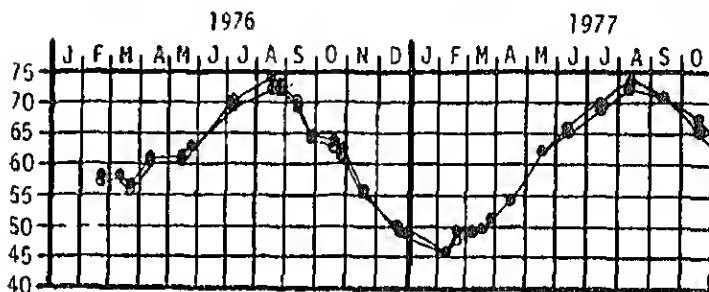
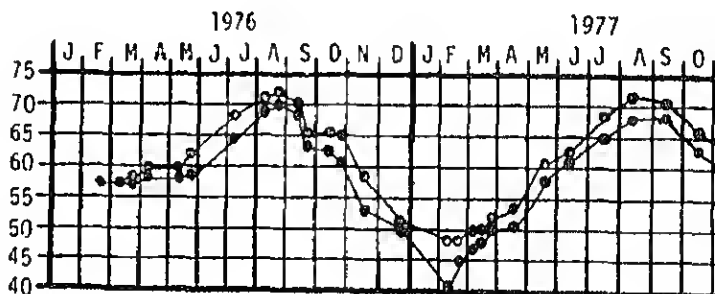
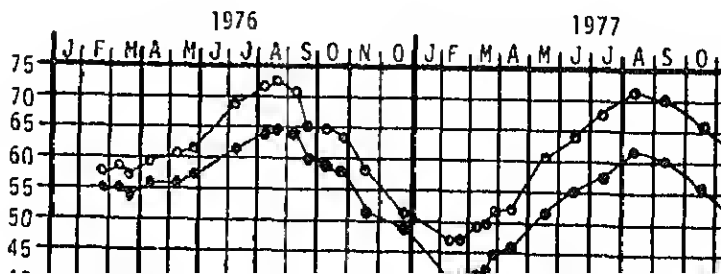
The variation of the soil temperature with time and for different depths is given in Figure 37. These curves show the characteristic sine wave shape and amplitude change with depth, and for this test house, more variation in temperature was noted at the lower depths in the subsoil. This can be explained by referring to Table 20, page 76, which gives the temperature means and standard deviations for the test house on the Taylor formation. It can be noted that no data is given for depths 4 and 5.5 for the soil boring on the West side of the test house. The thermistor portion of the moisture-temperature cell installed at these two depths became inoperative a short time subsequent to installation. Consequently, the curves plotted in Figure 37 indicate average temperatures for the North and South sides of the test house, but only the East side temperature readings are plotted for depths 4 and 5.5. In this area, the East side would be protected from climatic variations much more so than the West side and consequently cooler.

A comparison of the variations in soil temperature with time from data given in Figures 35 and 37, and Tables 19 and 20, pages 75, 78, 76 and 79, are relatively similar. It may be concluded that both referenced figures would exhibit like variations with depth and time, if the thermistors in the lower soil depths on the West side of the house at 1314 Athens Street, Mesquite, Texas, had not malfunctioned. Soils on the West side of a house in this area are subjected to more intense variation with time and as a consequence, the temperature variations given in Figure 37, page 78, for depths 4 and 5.5 feet reflect North and South side temperature averages for one curve, but only West side temperature data for the second curve at each depth, for this test.

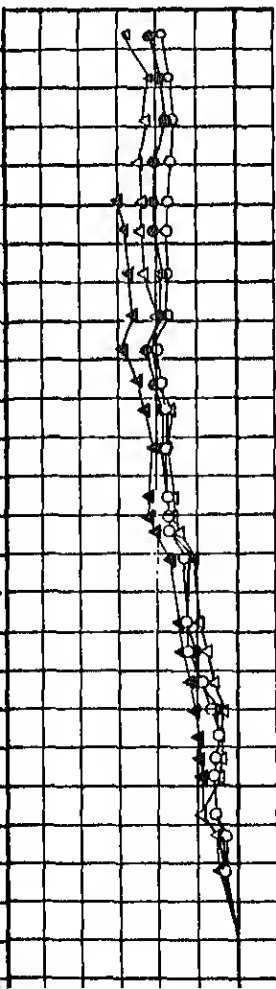
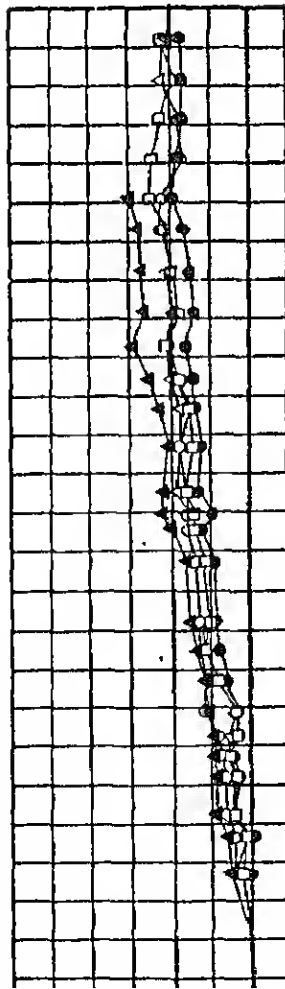
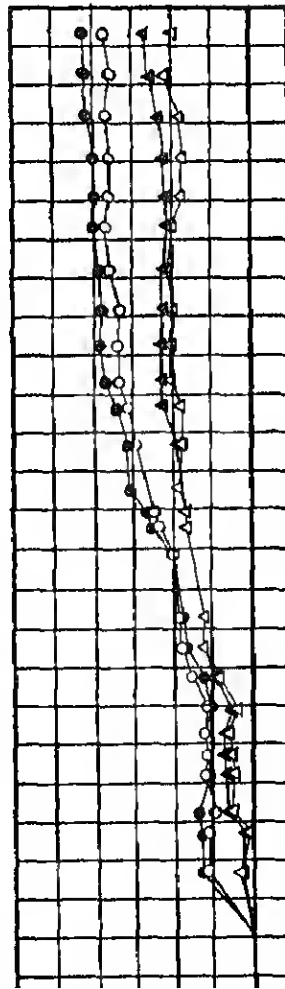
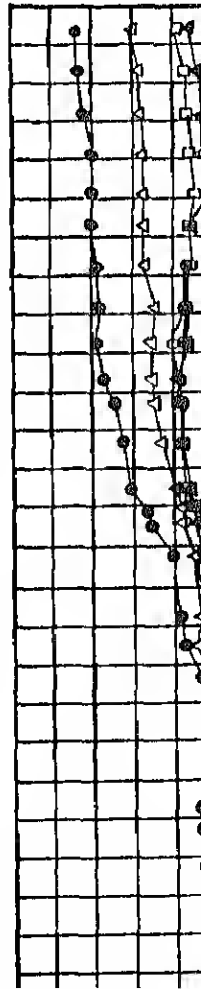
Figure 41 and Table 22 show absolute differential movements with time along each side of the test house. Figure 41 illustrates the increasing stability of the foundation subsoil with time, and also the lack of influence associated with climatic conditions.

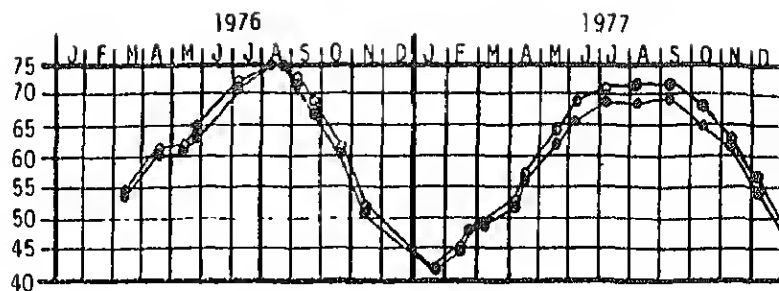
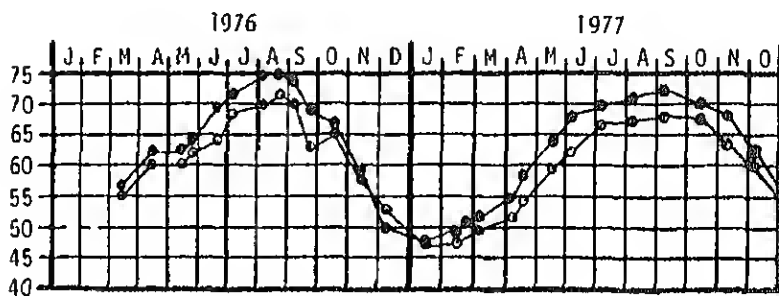
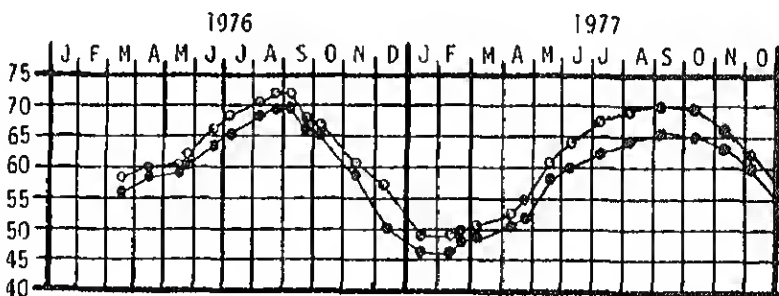
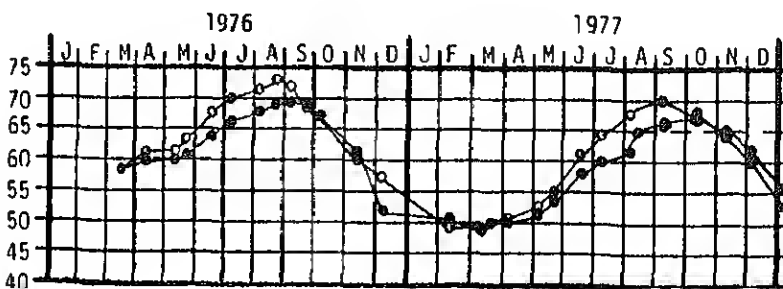
Fig. 43 Soil Moisture Content - Lean Concrete Barrier  
1137 Eastwood Drive, Lewisville, Texas

Data acquisition for variation in soil moisture content with time, as given in Figure 43, commenced upon completing all tasks associated with utilizing the lean concrete barrier as a subsoil stabilization technique. Significant variation was noted in moisture contents as a function of time at all depths of interest.

The average Plastic Limit in the upper five feet of the soil at this test house was 24.75 percent. As indicated by Figure 43, the minimum requirement for the soil moisture to be a minimum of 2-3 percent above the Plastic Limit was not achieved for certain depths and different sides of the house. While some reading error is apparent in certain instances, the moisture content as taken from the moisture-temperature cells was not increased to the desired level.

As given in Section 4.4.1, 9,827 gallons of water were added to the soils beneath the floor slab and surrounded by the concrete barrier. Further, the entire volume of water was added to the soil from the interior of the house. The floor slab had a "cupped" configuration, and borings were made through the slab on the interior of the house governed by the high and low points determined by topographical survey. Further, testing of the soils in the upper five feet to determine whether or not the moisture content was increased to the minimum desired was also accomplished at the access points from the interior of the house. The moisture-temperature cells are installed in borings approximately 12-18 inches from the house perimeter which may result in the moisture gradient decreasing and recording less than the optimum of the instruments. If the preceding was the case, it is then possible that the installed instruments and the insitu soil do not have completely intimate contact resulting in readings that are less than desirable. The mass of soil enclosed by the vertical concrete barrier could have different moisture contents throughout and particularly have higher moisture contents at the in-

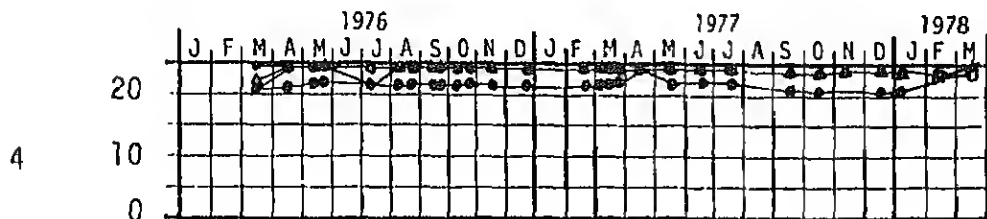
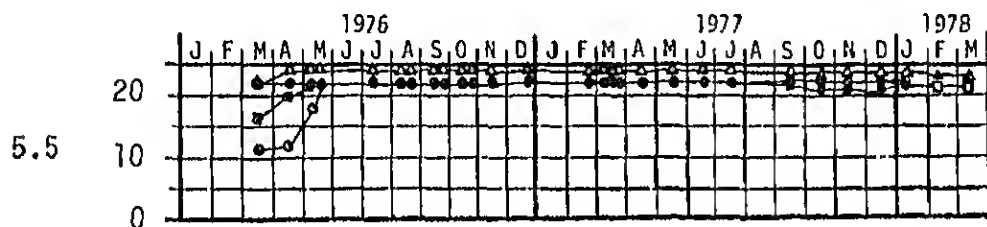
Fig. 45 Soil Moisture Content - Lean Concrete  
4204 Culmer, Balch Springs, Texas

For the test house at 1137 Eastwood Drive, Lewisville, Texas, the condition of the subsoil beneath the slab interior was largely indeterminate. However, knowing the slab interior was lower than the perimeter indicated more desiccated condition. Even though, laboratory testing showed the subsoil moisture within the house interior was raised by the addition of water to the desired value, there was nothing to preclude moisture migrating downward as well as laterally. This could reduce the moisture content of the

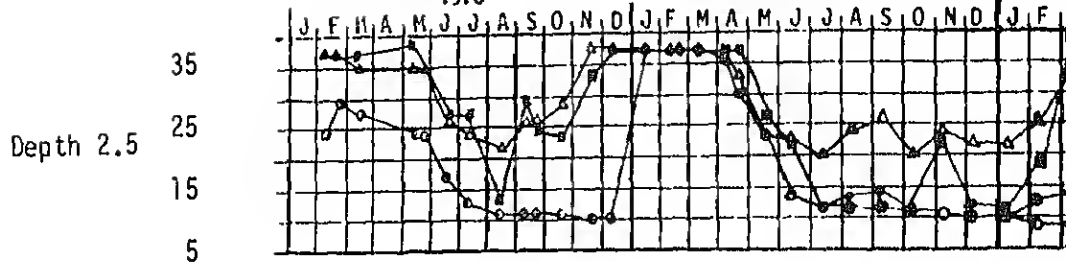
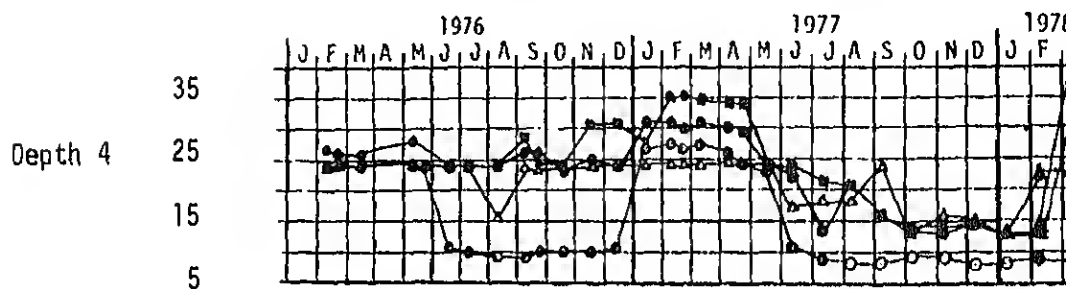
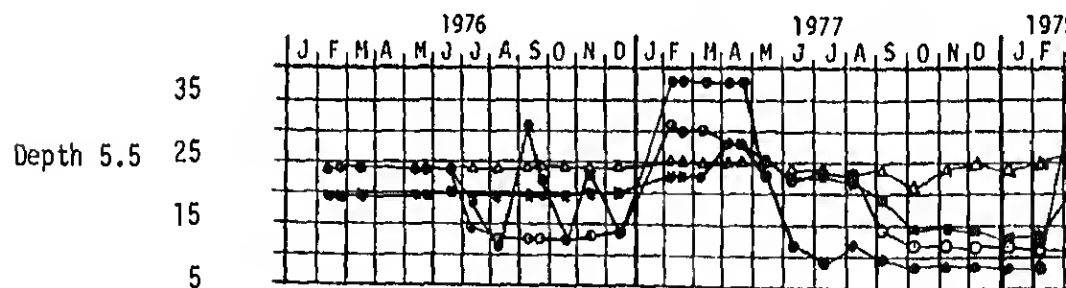
Fig. 52 Soil Moisture Content - Subsurface Irrigation System - 5807 Fess Street, Dallas, Texas

The action of adverse climate is known to initiate soil volume change with time, and corresponding vertical movement. The subsoil moisture data as given in Figure 52 vividly show the effects of climate on moisture stability in a subsoil. The extreme variation with time on all sides of the house and most depths indicates climatic influence over soil moisture.

For the test house at 5807 Fess Street, Dallas, Texas, a large cotton tree was located in the proximity of the Northeast corner of the house, and the remainder of the yard was barren. The moisture-temperature cells were installed in borings at the midpoint of each side of the perimeter. A much wider variation in moisture contents at all depths was observed for the instruments in the North and East side borings. This increased magnitude of variation is not considered due entirely to climate when considering the remaining curves. It is believed the root system of the tree is magnifying climatic effects particularly at the lower depths of interest.

The investigation established among the index properties an initial moisture content of 24.2 percent at the test house at 5807 Dallas, Texas. The average Plastic Limit was 24.5% with a minimum content below the Plastic Limit of approximately 5%. The Plastic Limit of Montmorillonite clay mineral was 25.8%. All of these values for a soil depth of five feet. The relatively close initial water content and Plastic Limit again illustrates the effectiveness of the system in causing the soil to give up and take in significant water as indicated in Figure 52, page 116. It is also noted that

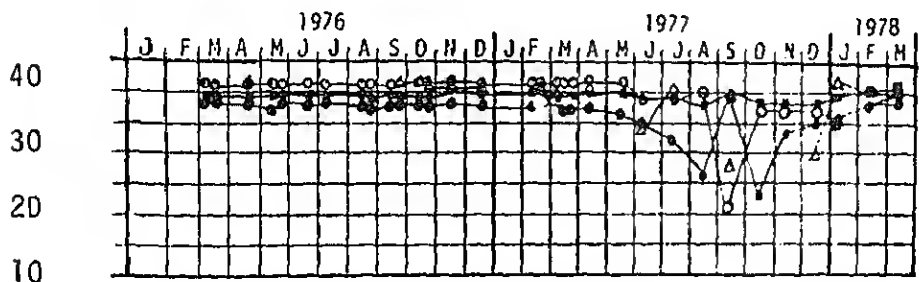
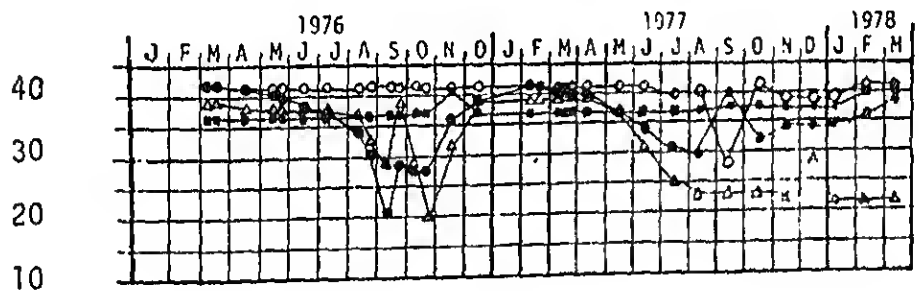
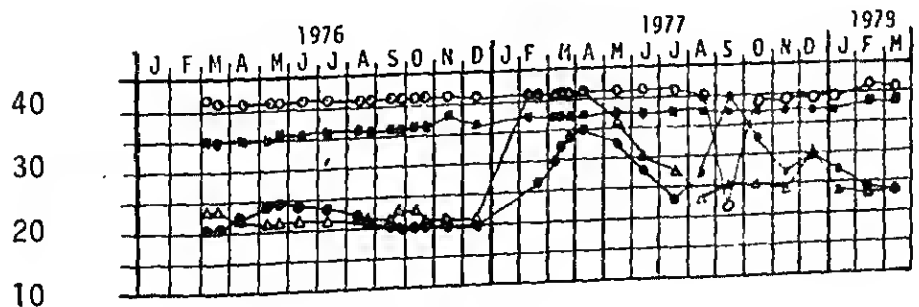
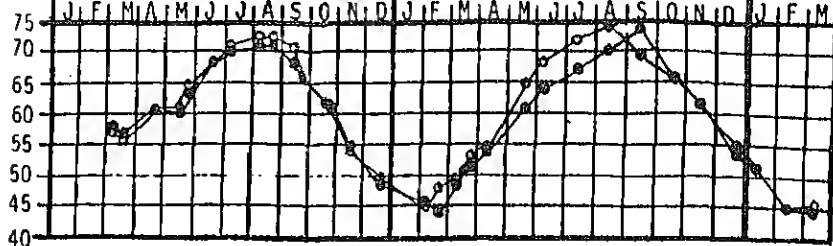
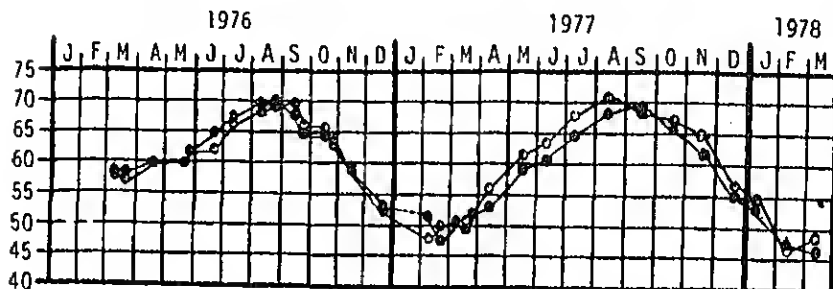
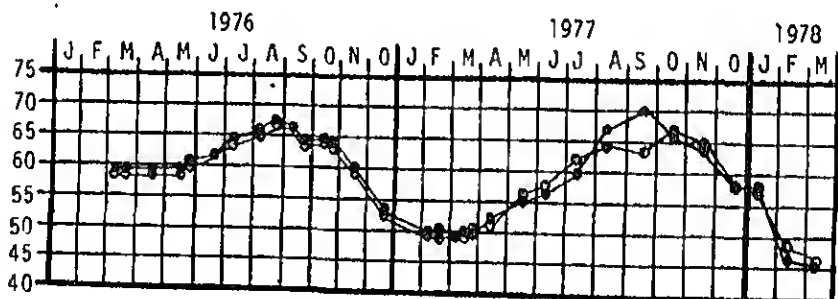
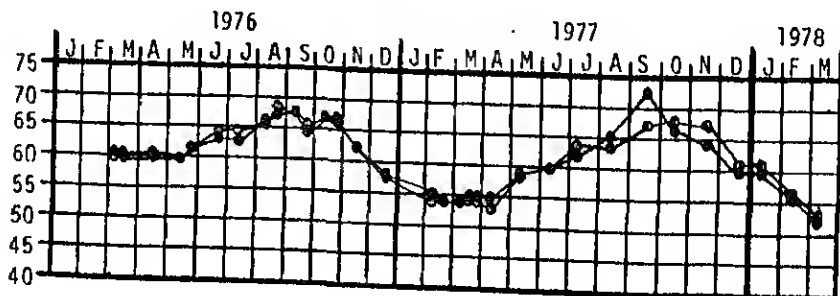
Soil Moisture Content - Sub-Surface Irrigation

sly been noted that this formation was dense and contained cracks and fractures. Further, the soil within the depths of fine sand and silt materials. Consequently, water could not be utilizing fracture paths initially. As these avenues closed, water through the subsurface soils would depend on the soil permeability for adequate distribution. The mixture of silts and sands within the soil provide the soil matrix with a higher permeability and more water migration. This condition is indicated with exceptions by the curves indicated by depth 4, the anomaly indicated by wells on the East and West sides of the test house are considered factors. These significant variations in moisture contents within the periods and at such a depth would not occur so abruptly.

Data given in Figure 54 are appropriate only for the time the subsurface irrigation system was operative. Beyond that time, data values reflect effects modified by a foundation watering program the new test house initiated after discussion with research personnel.

The effects of climate are not as extreme at the test house at 3513 Heath Street, Mesquite, Texas. The soils investigation established among index properties a natural moisture content of 29.5%. The average Plastic Limit was 31.8% and the maximum deviation of moisture content was 15%. These values are for the upper five feet of soil. It should be noted that the deviation of moisture content given was for the upper one foot of soil. Below the depth the average moisture content of the soil was 32.3 or slightly above the average Plastic Limit of 31.8%. The average percent of moisture was 32.3 within the depths of interest of the soil. As the subsurface irrigation system was installed at the approximate depth of moisture deficit it would follow the moisture content would be raised to the soil moisture demand requirement and remain stable while the system was operative as shown by Figure 54, page 119. At other depths of interest, more variation occurred however, as the natural moisture content existed above the Plastic Limit the demand would be less. This variation, at the lower depths, while the system was in operation, could be caused to some degree by climatic effects but may be primarily due to variations in subsoil properties.
